INVESTIGATION ON BANK STABILTY IN THE NILE RIVER AT Km 552.4 D.S ASWAN DAM

Samir A. S. Ibrahim

Hydraulics Research Institute, National Water Research Centre, Egypt.

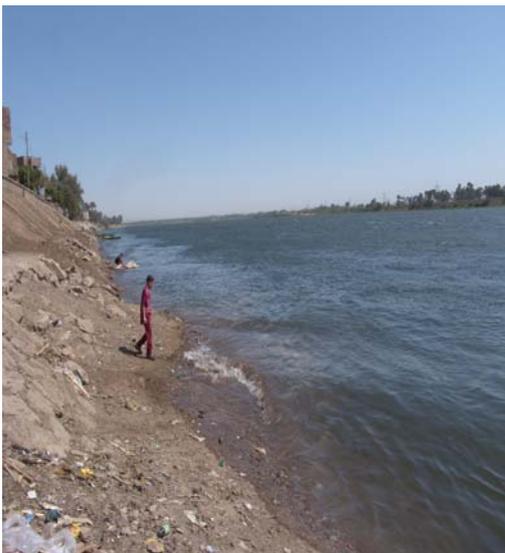
The western bank side slope is 1:1 up to bank height of 3 m. There is 4 m berm width at bank height of 3 m followed by another berm of 2.0 m width, then side slope of 1:1 until 1 m below the minimum water level. The bank was pitched by line stone from period more than 15 years ago. Some holes and small failure in the bank were appeared as shown in the Photo. 1.

Photo 1. General view of the bank with some stones for bank and toe protection

It is recommended to maintain the bank protection at that area where it established since 15 years ago and mentoring the scour holes should be done.

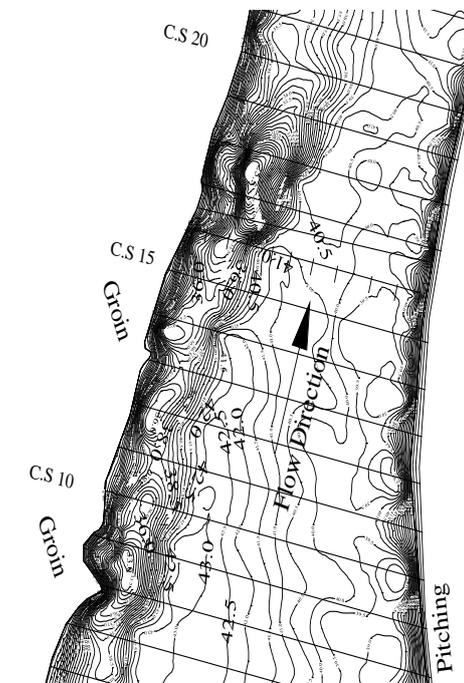
The width of the river at that part is very narrow where it reaches to 300 m. The average bed levels at the middle and eastern side of the reach range from 40 m to 43 m above MSL. There are three big scour holes in the area of about 1200 m long and 100 m width near to the western bank along the village. The first hole has two centers and is located between cross sections No 8 and No 10. The lowest point of it is 36 m above MSL. The second hole also has two centers and is located between cross sections No 12 and No 14. The lowest point of it is 35 m above MSL. The third one is located between cross sections

No 17 and No 18. The lowest point of it is 25.5 m above MSL.

There are two groins perpendicular to the western bank of the river reach. The first groin with a length of 25 m at section No 8 which caused local scour reached at the surrounded area to level of 33.50 m above MSL. The second groin has a length of 10 m at section No. 12.

Fig.2 Contour map of the surveyed area 2008 (from C.S. 6 to 21)

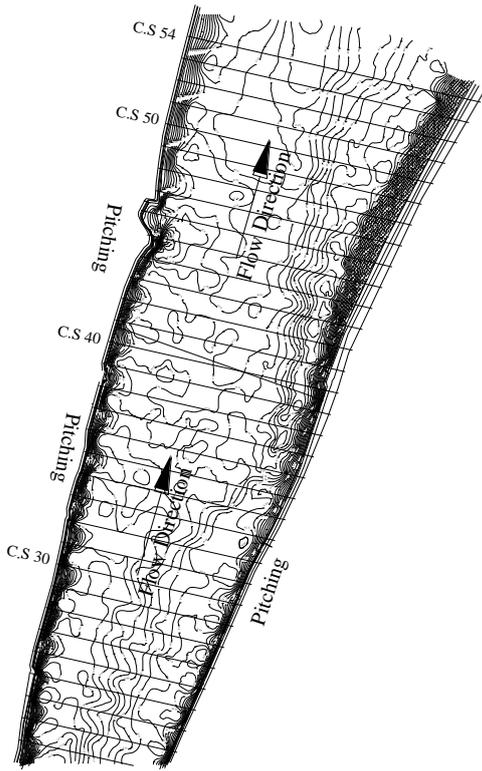
Fig.3 Contour map of the surveyed area 2008 (from C.S. 22 to 54)

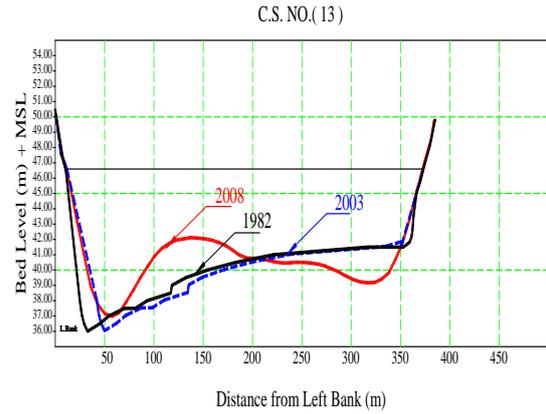
Comparing the bed profile resulting from contour map of 2008 with that one resulting in 2003 and 1982 appeared that, the three scour holes existed before 2003, the centre of the holes did not move until 2008 and little change was occurred in the scour depth from 2003 to 2008. Big change in the scour depth was occurred from 1982 to 2003. The Figures No 4 to No 8 show comparison between the bed level at years 2008, 2003 and 1982 at sections 8, 9, 13, 16 and 17.

Fig.6 Comparison between the bed level at years 2008, 2003 and 1982 at C. S 13

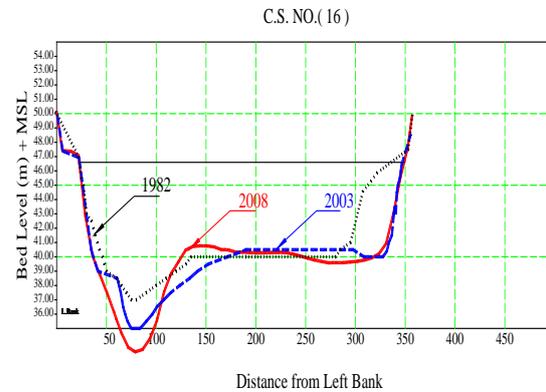
Fig.7 Comparison between the bed level at years 2008, 2003 and 1982 at C. S 16

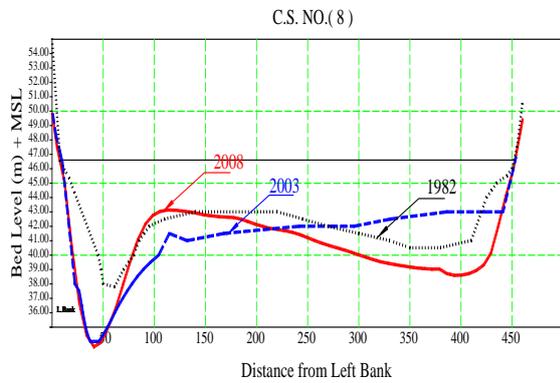
Fig.4 Comparison between the bed level at years 2008, 2003 and 1982 at C. S 8

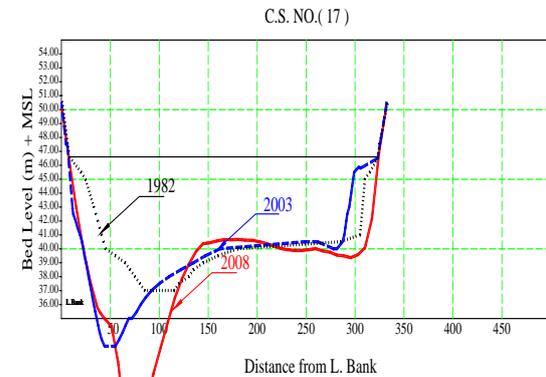
Fig.8 Comparison between the bed level at years 2008, 2003 and 1982 at C. S 17

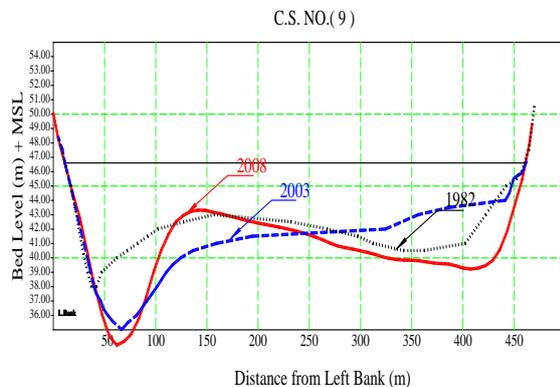
Fig.5 Comparison between the bed level at years 2008, 2003 and 1982 at C. S 9
