INVESTIGATION ON BANK STABILTY IN THE NILE RIVER AT Km 552.4 D.S ASWAN DAM

Samir A. S. Ibrahim

Hydraulics Research Institute, National Water Research Centre, Egypt.

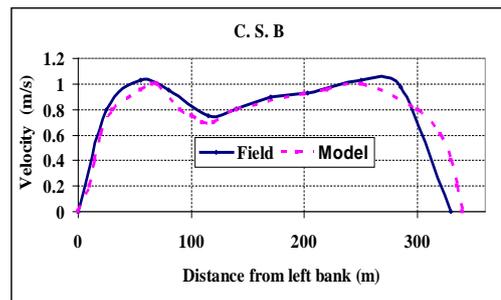
Fig.9 Measured and the simulated velocity at C. S B

The water surface slope was adjusted in the model by changing the Roughness Coefficient until a similar slope to the prototype was obtained. The discharges of 1732.6 and 2067.9 m^3/s were used for calibration of sections B and E respectively. The measured velocity profiles at sections B and E were compared with those resulting from the numerical model. According to this comparison, change in roughness coefficient at some grids was occurred until good agreement was achieved between the measured and resulting velocities at sections B and E as shown in Figures 9 and 10.

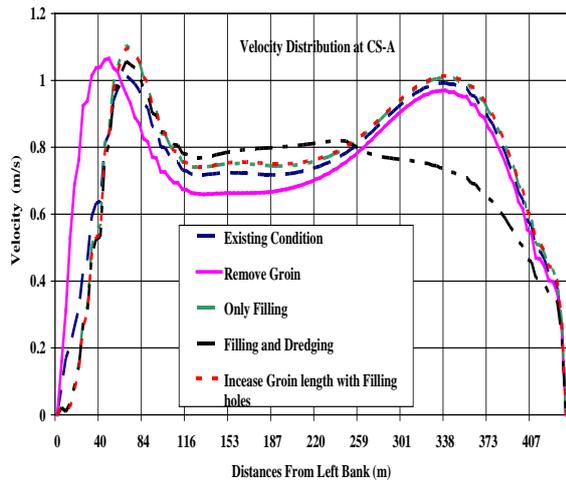
Fig.12 Velocity distribution at C. S A
($Q=2066 \text{ m}^3/\text{s}$)

compared by their corresponding of the existing condition. This was done by identifying 4 cross sections distributing over the whole reach to have the abovementioned comparison. The location of these 4 cross-sections is shown in Figure 11. The results as a comparison with existing condition are shown in Figures 12 to 16.

In order to decrease the velocity beside the western bank, different scenarios were simulated separately on the program as follows: (a) existing condition, (b) remove the located groin at section No 8, (c) filling the lower part of areas (the scour holes) located at the western part to a level of 40.0 m above MSL, (d) filling the bed and dredging the channel in areas closer to the scour hole until level of 40.0 m above MSL and (e) extending the second groin from 10 m to 60 m length in addition to filling the lower part of scour hole to level of 40.0 m above MSL. Level 40.0 m was preferred as dredging and filling level because it is convenient for navigation.
